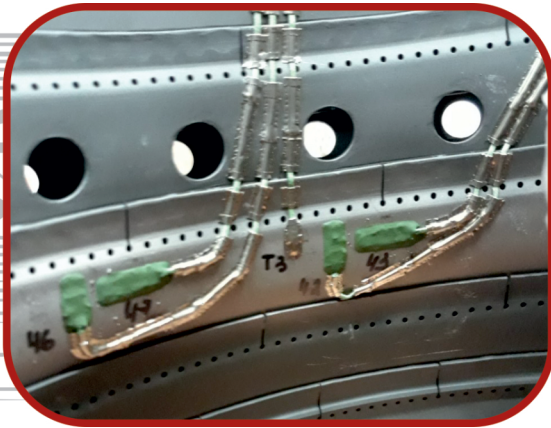
Remedial works due to cracks propagation on the walls of the combustion chamber. HPM nickel-chromium wire strain gages were installed using VPG HG-1 cement. Elongation cable routes are protected with spot-welded heat-resistant foil. In total, 60 strain gages were used for dynamic test of the combustion chamber.

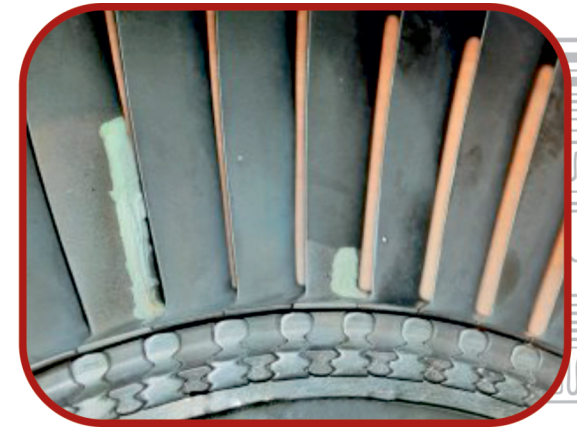
Certification works for the free turbine blades at 60,000 rpm. An 8-channel telemetry system was used, implementing 8 strain gages installed in critical points of the blades. Dynamic test is carried out throughout entire engine test program (around 6 hours).

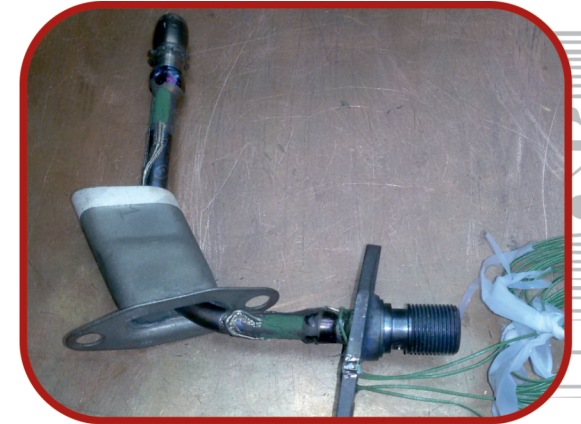
Strain test of fuel injectors installed in the combustion chamber flame tube. Two HPM 3 mm nickel-chromium wire strain gages were installed on each igniter with ceramic cement VPG HG-1. Temperature was controlled using custom-made chromel-alumel thermocouple with core diameter of 0.3 mm.
